iLeaf Weather Stations

Guide to how weather stations should NOT look:

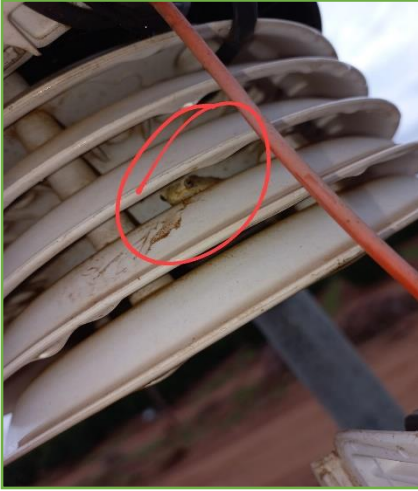
Frogs, Spiders and Hornets climb into the gill screens. This causes inaccurate Temp measurement

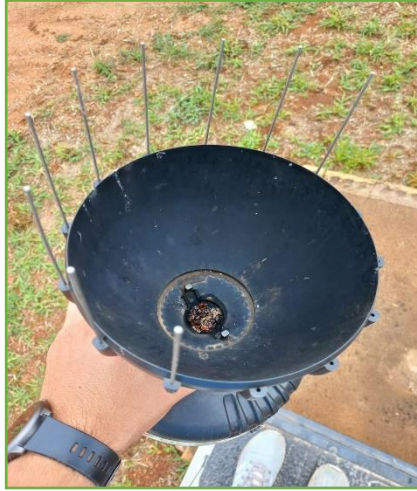
Rain Bucket blocked. Cause no rain measurement

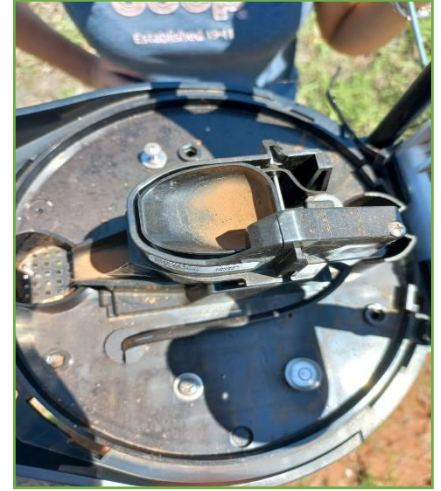
Sand, spiders or bugs on Rain bucket tippers. Cause inaccurate rain measurement. Unscrew Rain Bucket to clean this

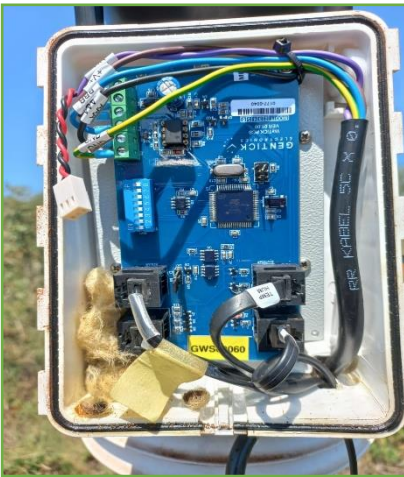
Spider webs, Gecko eggs and dust. Cause malfunctioning motherboard parts. Resulting in expensive logger replacement

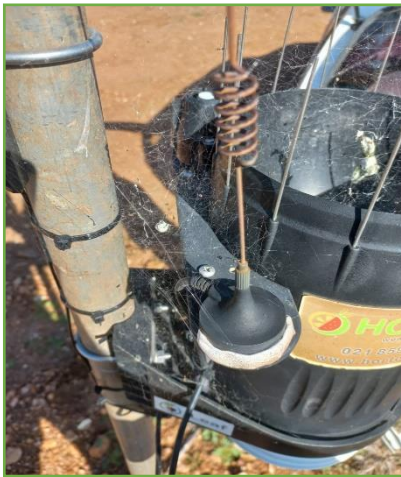
Rusted Antenna, resulting in bad signal connectivity. Inform iLeaf if any parts are rusted. This needs to be replaced

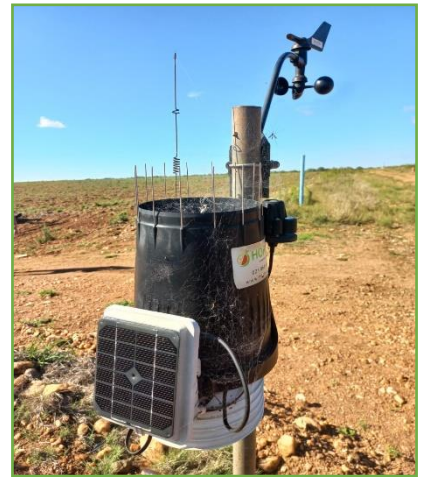
Station covered in spider webs or dust, means there is a high chance of more critters inside. Station needs a clean.

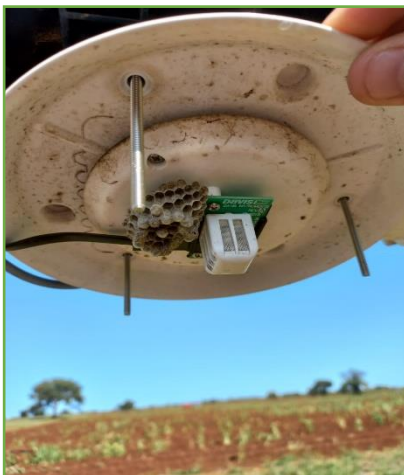
The Temp_RH sensor is inside the Gill Screens. Hornets make nests and frogs climb in there. This gives inaccurate temp and relative humidity readings.

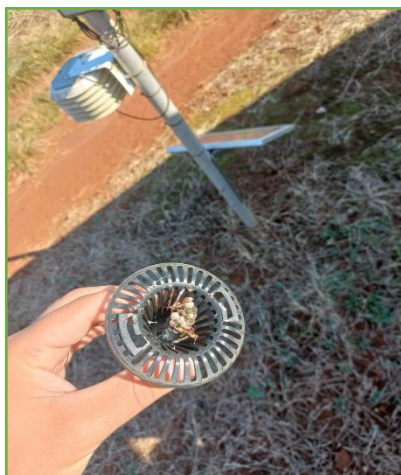
Blocked Rain Gauge. No rain can pour through to the rain tipper resulting in NO rain measurement

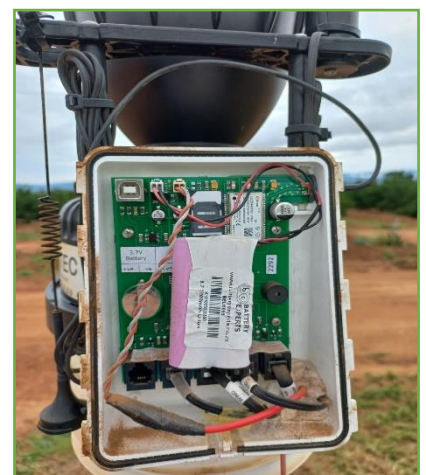
Dust on motherboard components. Make sure it stays closed and clean. If not, resulting in expensive logger replacement
